Township of Wainfleet

Roadside Safety Study:
Guide Rail and Unprotected Hazard
Inventory, and Condition and Risk Assessment

October 2017

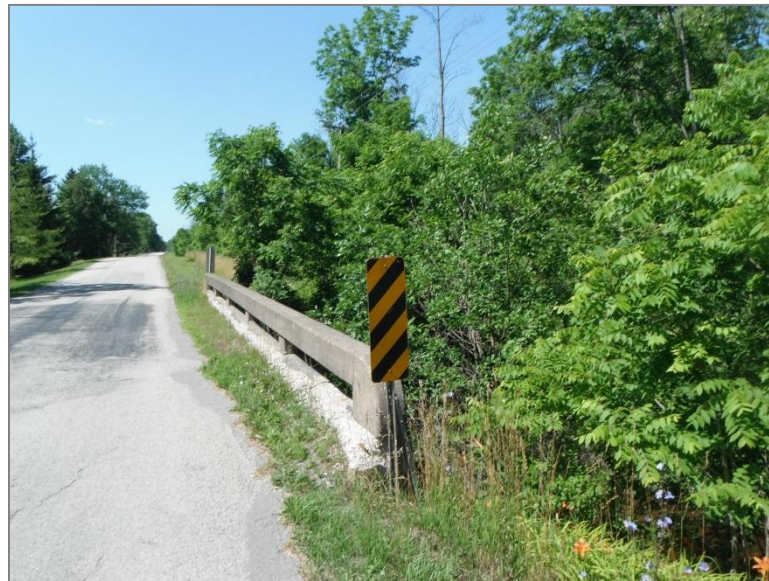
Figure 3-1
Fully-Unprotected Hazard (Mill Race Road)

Steel-beam guide rail, with or without channel, was the treatment of choice due to the effectiveness and life-cycle economics of this system. One example of an unprotected hazard was found on Mill Race Road between Buliung Road and Church Street, as shown in **Figure 3-1**. In this instance, the recommended installation length was 56 metres.

The approaching end of this new system would be in the minimum roadside clear zone; therefore, a suitable end treatment was recommended. The end treatment of choice in conjunction with steel-beam guide rail was the guide rail SoftStop, based upon its effectiveness at design speeds up to 100 kilometres per hour, its ability to be retrofitted without grading modifications to the roadway shoulder or ditch/drainage

To ensure that the approaching and leaving ends of the system are clearly visible to road users and winter maintenance staff, a final recommendation was made to install Wa-33 Object Markers (left or right as applicable) directly in front of the system for both directions of travel. Currently, there is one double-sided object marker on the upstream side of the hazard; there should also be a double-sided marker on the far side of the hazard. There should also be consideration for the installation of snow plow markers and delineation strips to further assist drivers.

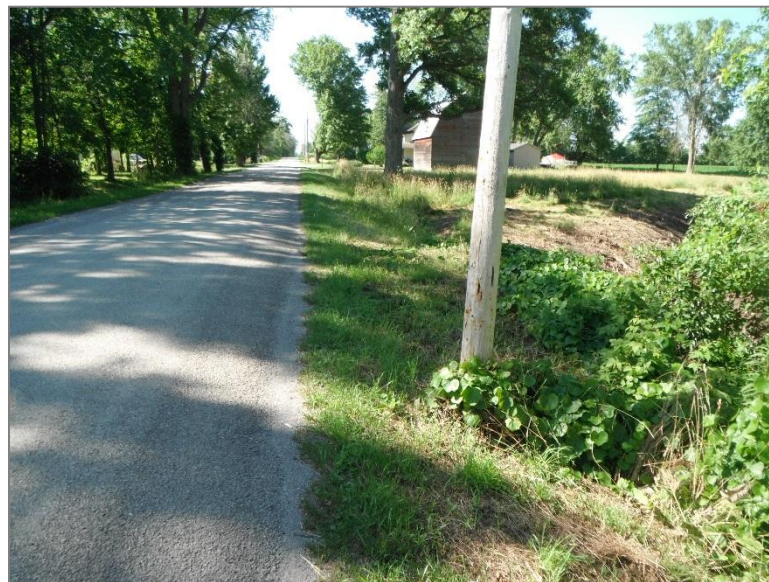
Figure 3-2
Fully-Unprotected Hazard (Prestman Road)

Utility poles were also frequently within the clear zone on some roads such as along Prestman Road, shown **Figure 3-2**. Since installing a guide rail or series of guide rails along the total length of the road where the utility poles are present is impractical from a cost perspective, it is recommended that delineation in the form of hazard markers be installed to warn vehicles of the roadside hazards.

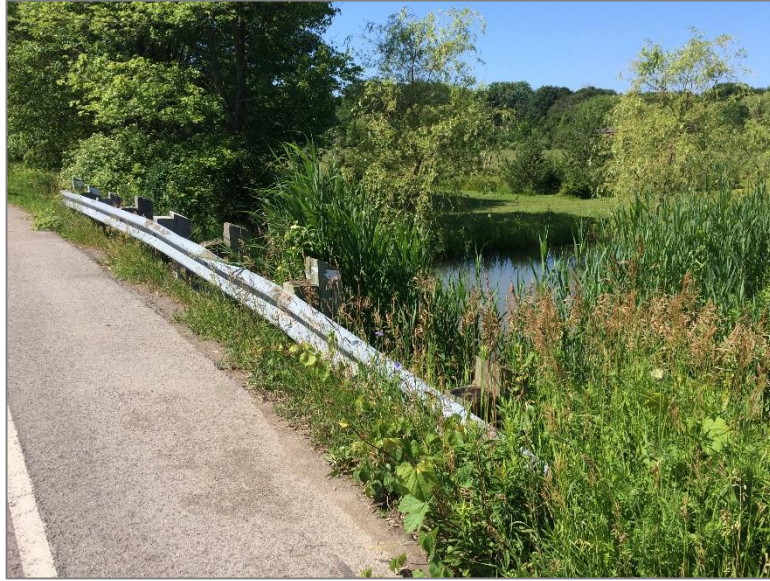
Figure 3-3
Partially Protected Hazard (Cement Road)

Many locations were identified where: a hazard was present within the minimum roadside clear zone; and roadside protection in the form of guide rail was provided, but the system proved to be obsolescent, in poor condition, and/or of insufficient length to adequately shield the hazard from both directions of travel. One example of a system that is inadequate to protect a hazard is located on Cement Road between Highway 3

and Lakeshore Road and is shown in **Figure 3-3**. In this instance, 16 metres of steel-beam guide rail, in poor condition, and of insufficient length, is present.

To upgrade the roadside protection to current standards, and to adequately shield the hazard, simply extending the steel-beam guide rail is impractical. In this instance, the recommendations are to: remove the 16 metres of steel-beam guide rail; replace it with 50 metres of steel-beam guide rail; install energy attenuating end treatments on the approach and departure ends of the system; and provide object markers, snow plow markers, and delineation strips visible to approaching traffic from both directions of travel. Over time, this upgraded form of roadside protection will adequately shield road users from the hazard without introducing other risks into the roadside, while being less-costly and longer-lived to maintain.

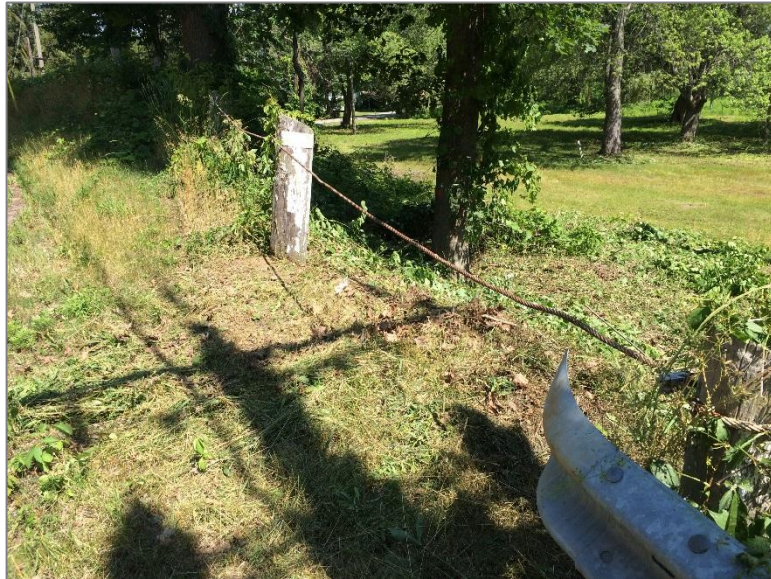
Figure 3-4
Design Conformance Issues (Lakeshore Road)

In this instance, the water hazard and embankment would be located within the run-out area and a vehicle colliding with the end treatment would likely continue to run into the water. Unfortunately, due to the geometric constraints it won't be possible to provide this run-out area. However, delineation will help drivers remain alert to the hazard and result in less roadway departures.

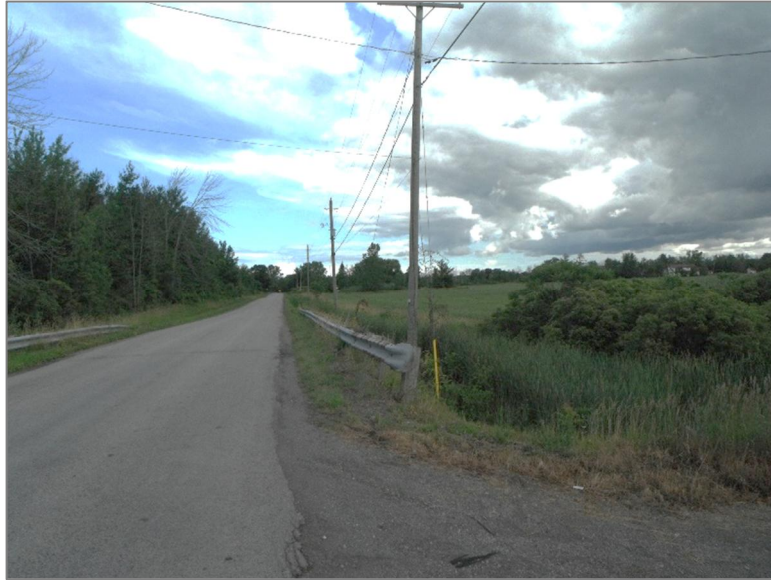
**Figure 3-6
Access Conflict on Approach End (Hewitt Road)**

In extreme cases, such as where an intersecting roadway or driveway is present immediately upstream of a fixed object hazard such as a bridge parapet, and the driveway return cannot be accommodated, other treatments which address the fixed object threat only (e.g., crash cushions such Quad-Trend may be considered). However, these solutions are costly, and do not address outflanking. Access relocation should be considered as a more cost-effective alternative, where feasible.

In the example shown in **Figure 3-6** located along Hewitt Road between Lambert Road and Regional Road 27, a driveway return with an object marker is recommended to replace the current end treatment.
