Township of Wainfleet

Roadside Safety Study:
Guide Rail and Unprotected Hazard
Inventory, and Condition and Risk Assessment

October 2017

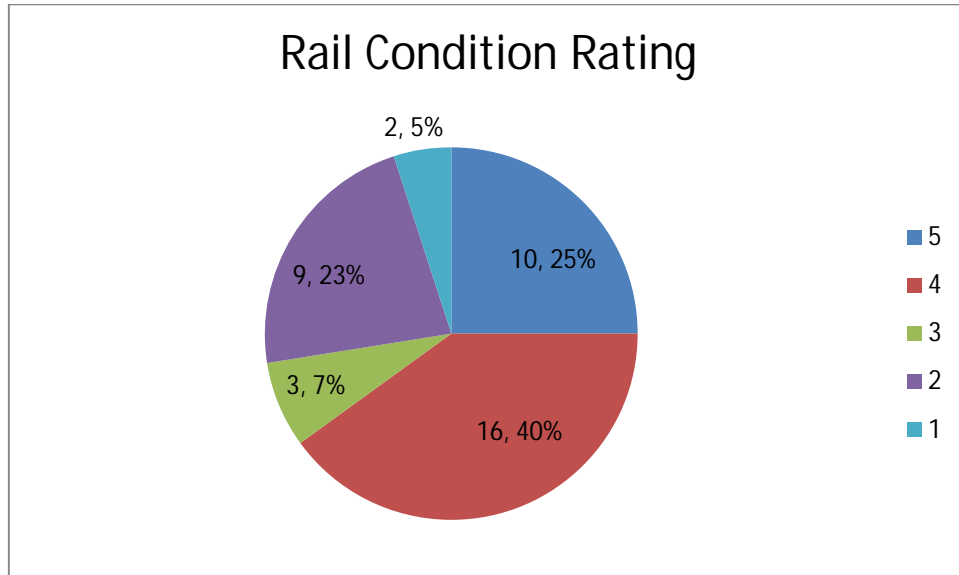
Figure 2-7
Rail Condition Rating

- As a whole, 65 percent of the **rails** reviewed had a condition rating of 4 or 5 indicating a favourable condition while the remaining 35 percent had a condition rating of 3 or less indicating the need for replacement;
- As a whole, 65 percent of the **posts** reviewed had a condition rating of 4 or 5 indicating a favourable condition while the remaining 35 percent had a condition rating of 3 or less indicating the need for replacement; and
- As a whole, 64 percent of the **block-outs** reviewed (applicable to box-beam, entrance or intersecting roadway, steel-beam, steel-beam with channel, and thrie-beam installations only) had a condition rating of 4 or 5 indicating a favourable condition while the remaining 36 percent had a condition rating of 3 or less indicating the need for replacement.

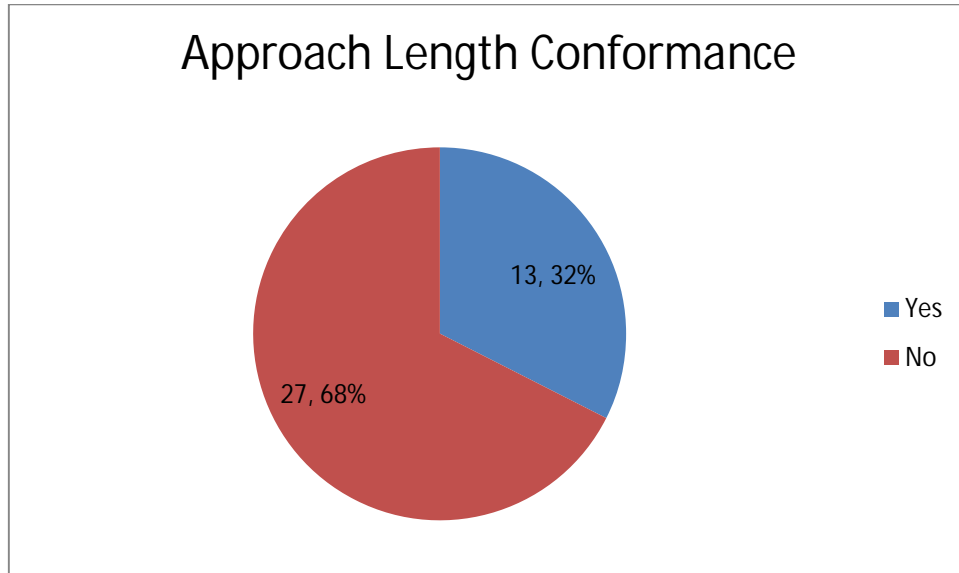
Figure 2-10
Approach Length Conformance

In comparison with the Transportation Associated of Canada's *Geometric Design Guide for Canadian Roads*³, the approach and departure lengths were reviewed for their conformance to the required lengths of need. **Figure 2-10** presents the approach length conformance while **Figure 2-11** presents the departure length conformance. Approximately one-third (32%) and one-half (50%) of the guide rails reviewed were determined to have an adequate approach or departure length for protecting motorists from a roadside hazard, respectively.

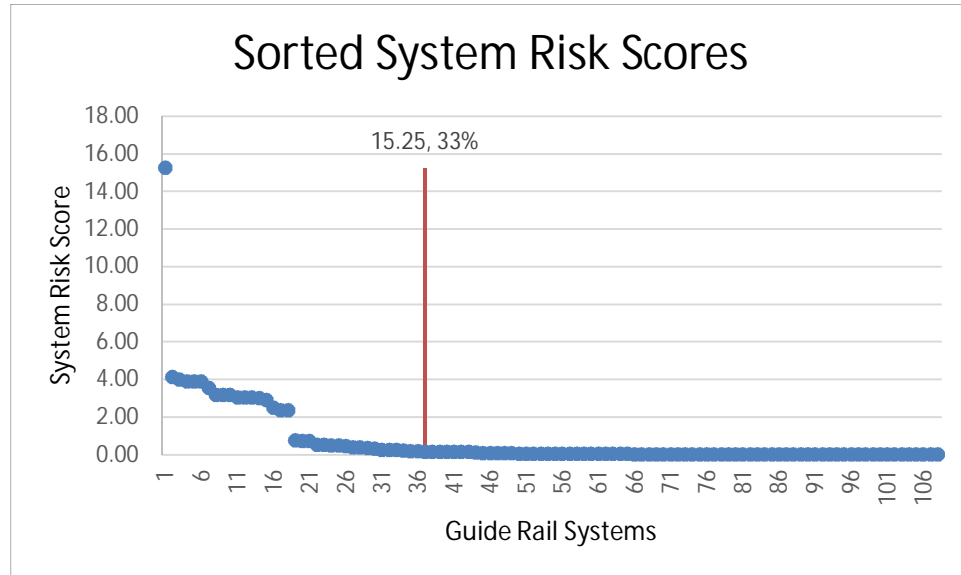
**Figure 2-12
 Sorted System Risk Scores**

score and **Table 2-4** presents the top five (5) unprotected hazards with the highest risk score; the high risk scores may be attributed to a number of factors including the roadway's AADT, the length of the guide rail, and the condition of the system or its ability to provide protection from the adjacent hazard. A summary of the sorted system risk scores is presented in **Figure 2-12**.
